BUILDING ENGINEERING REPORT (BER)

Building Name: Federal Building – 517 Gold Avenue SW
 Building No.: NM0024ZZ
 Location: Albuquerque, New Mexico

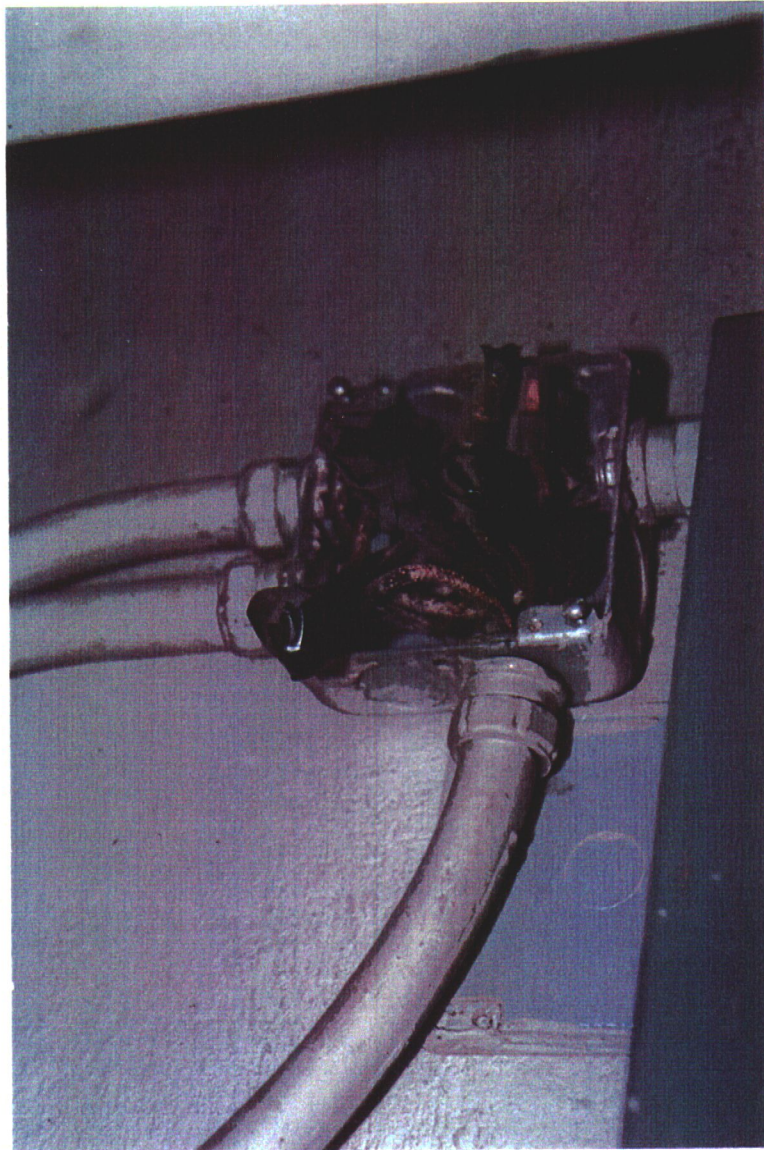
Much of the existing branch circuit wiring is over thirty years old and the insulation has become brittle. Insulation is cracked and peeling at terminations in the electrical panelboards due to the accumulated heating effects.

Branch Circuit Wiring Junction Box

It is recommended that the branch circuit wiring system from the lighting and power panels to the devices (receptacles, switches, light fixtures, etc.) be replaced to eliminate the unsafe wiring. It is also recommended that the loading on each branch circuit be checked and recircuited as necessary to eliminate any potential overload, and non-linear load problems resulting from existing inadequately sized neutrals.

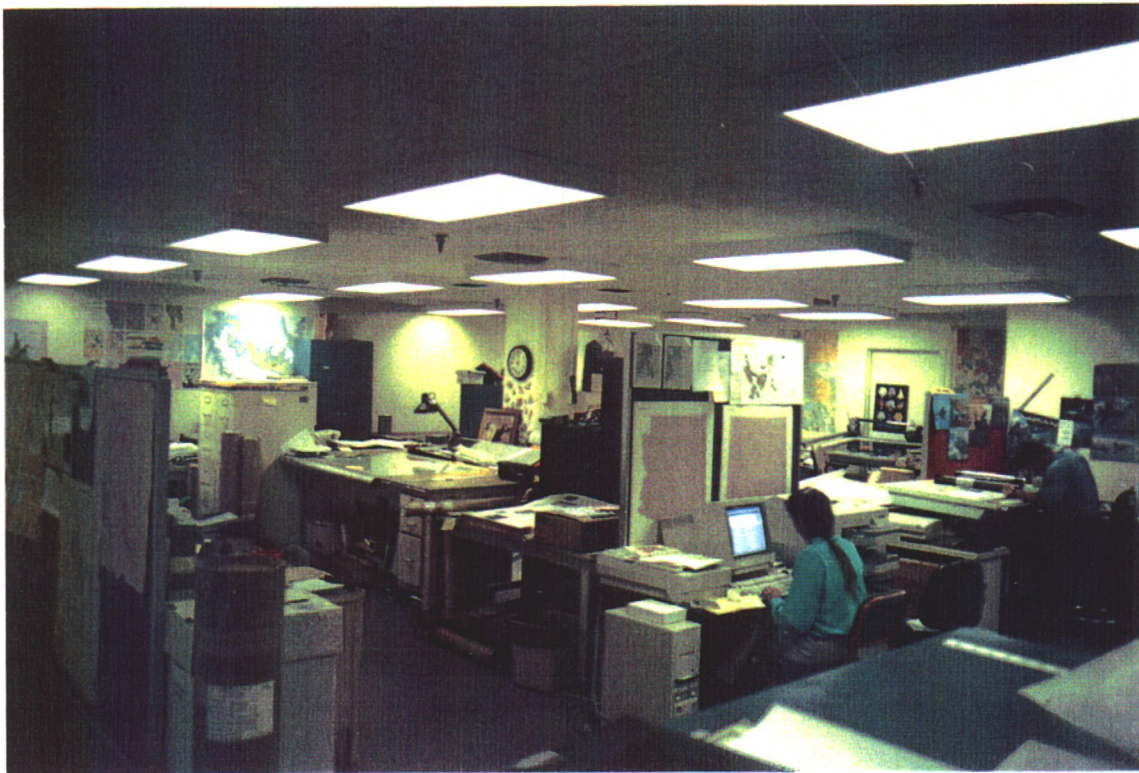
Sixth Floor

The sixth floor has a combination of, 1' x 4', suspended fluorescent and 2' x 4', surface-mounted fluorescent light fixtures with an existing gypsum board ceiling with glued-on acoustical tiles. It is assumed that the existing ballasts contain PCB's.

Existing 2' x 4' Surface Mounted Light Fixtures on Gypsum Board Tiled Ceiling

This work item is to replace the existing lighting on the sixth floor with, 2' x 4', parabolic fluorescent type fixtures, with energy-efficient electronic ballasts and T-8 lamps. The existing ceiling will need to be replaced with a new lay-in ceiling. The resulting product will match the upgrades which are to be or have been implemented on the other building floors.

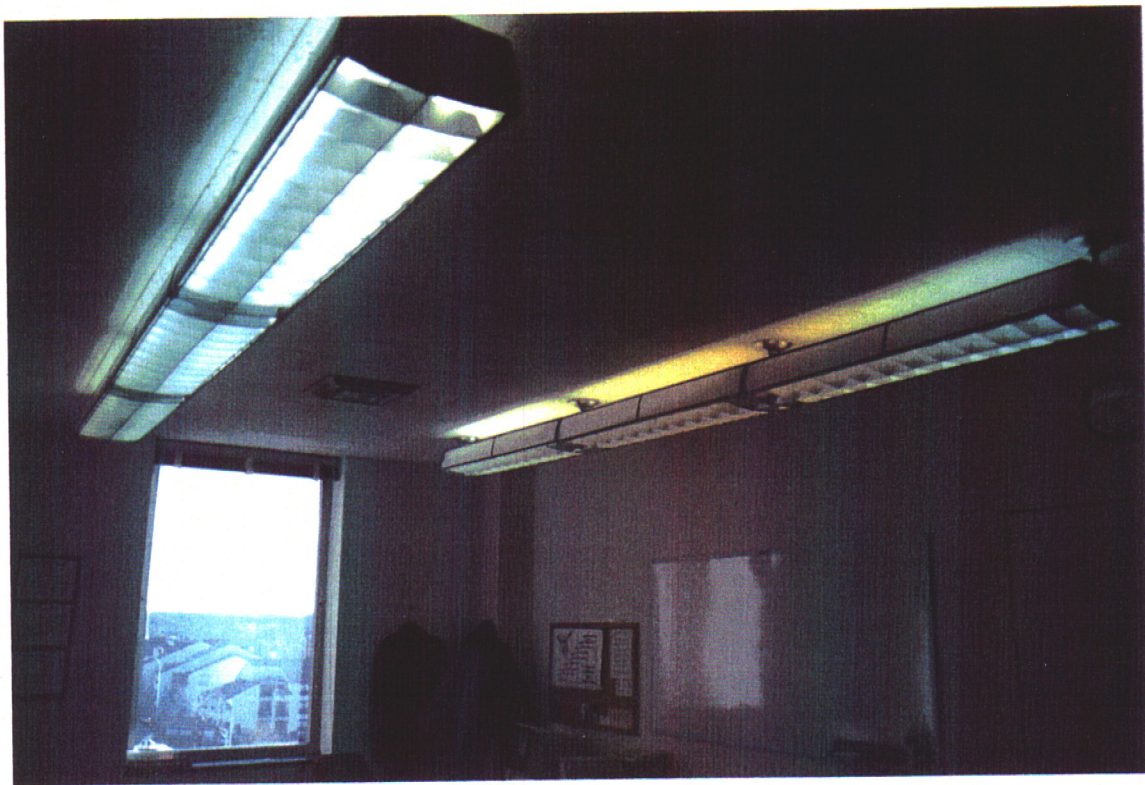
Sixth Floor

Existing 1' x 4' Louvered Light Fixtures Pendant Mounted on Gypsum Board Tiled Ceiling
